Manhole Inspection Summary

Manhole # S45MM_008MH

Insp Date: **3/25/08 3:37 PM**

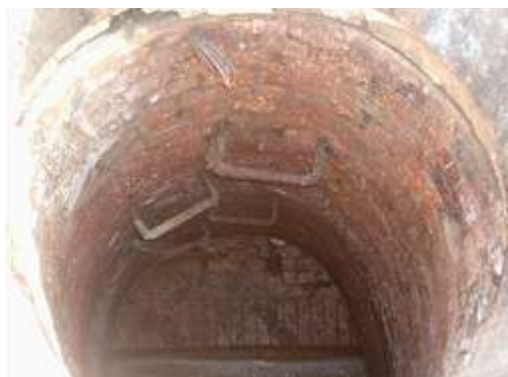
Defect 1

Condition: ☐ Sound ☐ Cracked ☐ Root Intrusion ☒ **Loose Brick** ☐ Deteriorated

Loose bricks

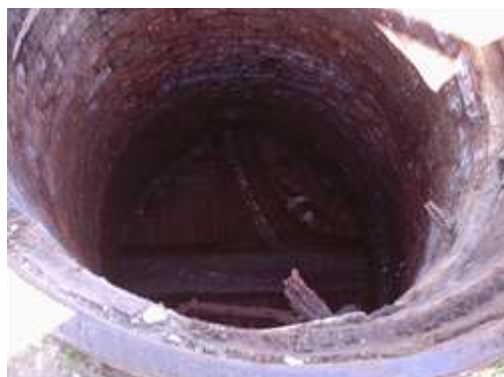
Defect 2

Frame Offset: **1** (in.)

Offset

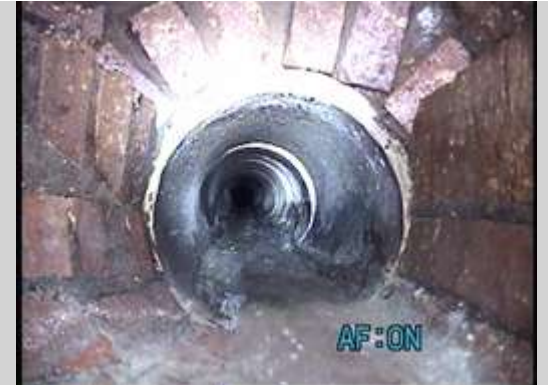
12 O'Clock Outflow

10 in. Circular Gravity Sewer
Pipe Out @ 12 O'Clock

Pipe Height: **10.8** (in.) Rod and Bar (Angled)
Pipe Material: **Clay** ☐ Pipe Lined
Invert Depth: **9.00** (ft.) Flow Characteristics: **Fast**
Deposits: ☒ None ☐ Mud ☐ Gravy ☐ Debris ☐ Grease
Silt Depth: (in.) Deposits Extent:
Infiltration: **None** Pipe Seal Cond: **Sound**

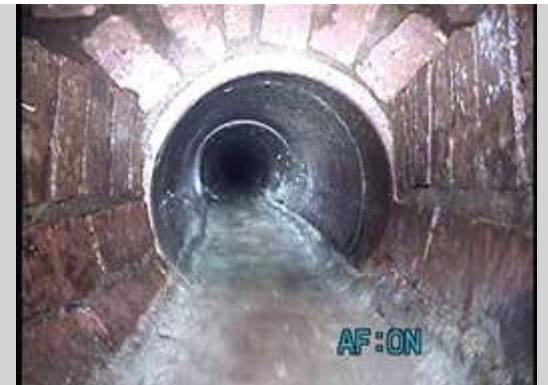
6 O'Clock Inflow

10 in. Circular Gravity Sewer
Pipe In @ 6 O'Clock

Pipe Height: **10.8** (in.) Rod and Bar (Angled)
Pipe Material: **Clay** ☐ Pipe Lined
Invert Depth: **8.80** (ft.) Flow Characteristics: **Fast**
Deposits: ☒ None ☐ Mud ☐ Gravy ☐ Debris ☐ Grease
Silt Depth: (in.) Deposits Extent:
Infiltration: **None** Pipe Seal Cond: **Sound**

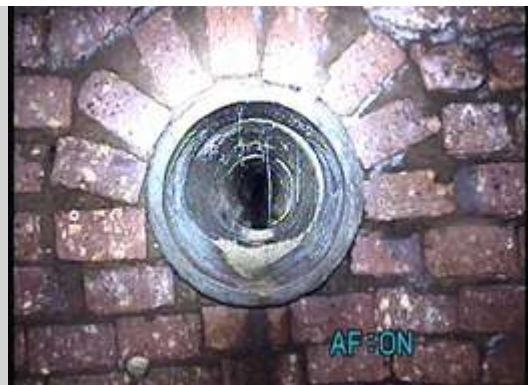
9 O'Clock Inflow

8 in. Circular Gravity Sewer
Pipe In @ 9 O'Clock

Deposits: ☐ None ☐ Mud ☒ ~~Sludge~~ **Debris** ☐ Grease

Silt Depth: **2** (in.) Deposits Extent: **Light**

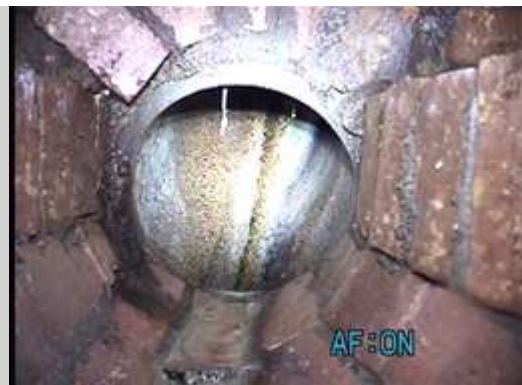
Drop In @ 9 O'Clock

Drop: Inside	Rod and Bar
Angled: Yes	Reading: 5.55 (ft.)
	Inv Depth: 6.55 (ft.)
Drop Condition: Open
